NEW SITE IDENTIFICATION (NSI)

1. Site Title: Contaminated Soil Around the TAN-607 Decontamination Shop Door	Site Code: TSF-52 NSI Evaluation Initiation Date: March 24, 2005
2. Task Lead For New Site: Wendell Jolley	Phone: 526-5990

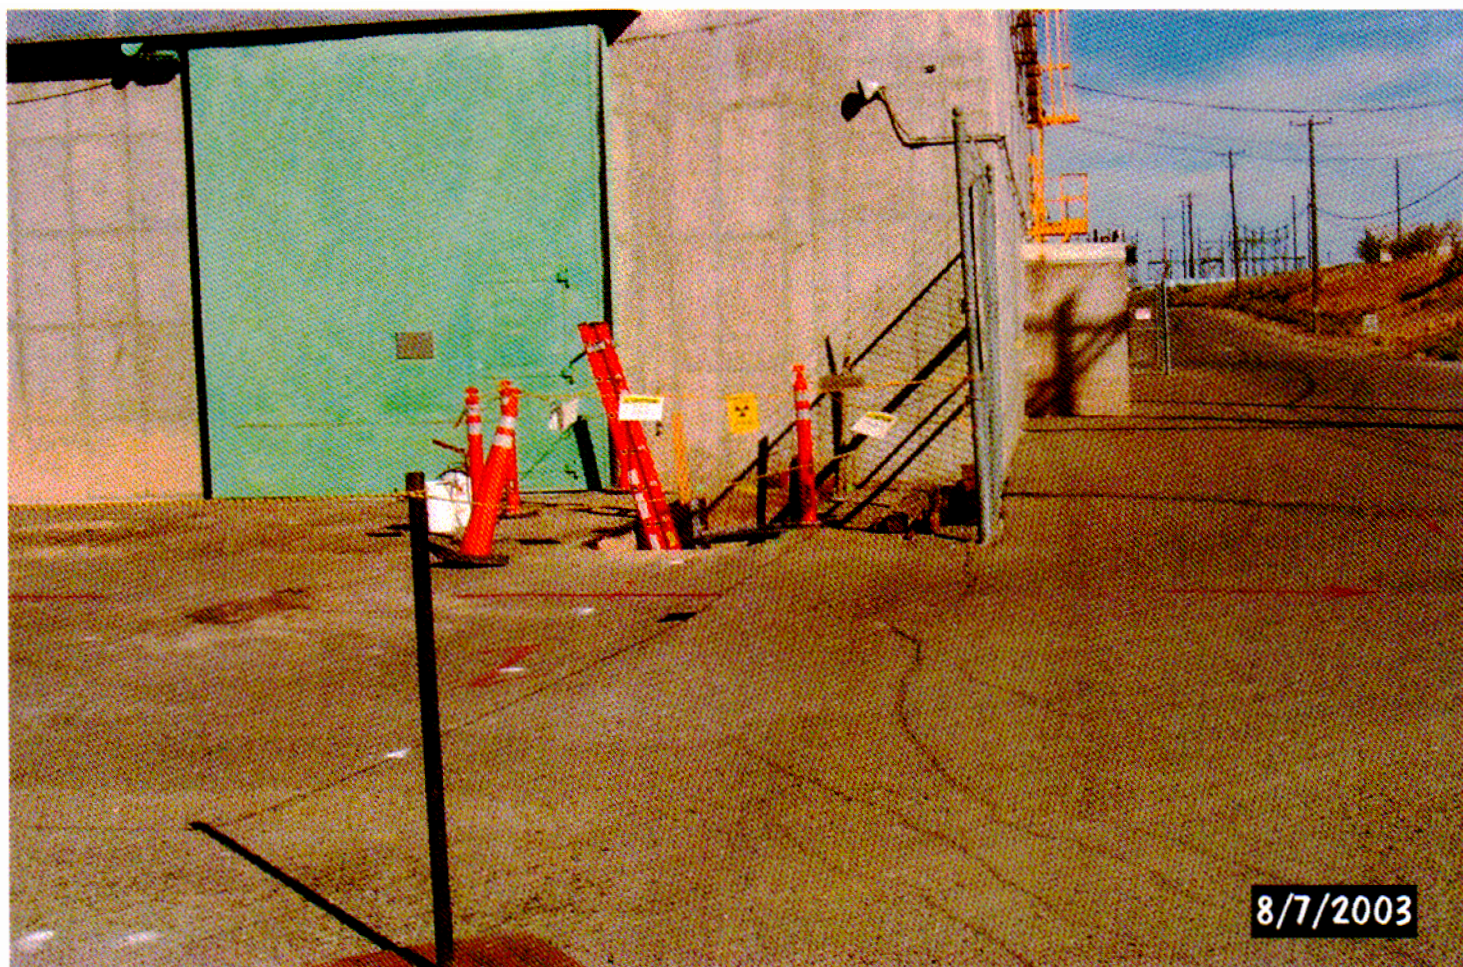
3. NSI Coordinator: Nielsen Burch	Phone: 526-5676
4. Initiator or Initial Observer: Nathan Wheldon (Portage Environmental, Inc.)	Phone: 528-6608
5. Description of Suspected New Site and Location: <p>The suspected new site is located around the Decontamination Shop Door on the west side of the southwest corner of TAN-607. The site was discovered while excavating a 2 inch discharge pipe (2" WDA-10027) leading from the TAN-607 Decontamination Shop Sump to Valve Pit #1. The process line carried waste from the TAN-607 Decontamination Room Sump to the TAN-616 Evaporator System. Radiological surveys of the soil under the asphalt revealed radiation levels above background. Digging commenced using a vacuum excavator and contamination was found along the west wall of TAN-607 to a depth of 6 ft. Radiological surveys of the area show varying degrees of contamination with counts as high as 400,000 dpm (40,000 cpm) on the soil next to the west wall of the TAN-607 building. The physical integrity of the piping was confirmed through visual inspections, and that no visible leaking occurred during the flushing and sampling of the pipe. A portion of the pipe is still protruding through the wall. Figure 1 below shows the trench that was excavated for the cutting, capping, and removal of the pipe. Because the excavation was made for purposes of accessing the line and not to determine the extent of contamination, contaminated soil may exist in and beyond the confines of the excavated area. A drawing showing the relation of this area to the TAN-607 facility is Attachment A.</p> <p>Historical process knowledge indicates that there was at least one release from the firewater system in the decontamination room. The firewater system is located next to the overhead door and the falling water could have easily leaked under the door, resulting in the soil contamination observed during the excavation.</p>

Figure 1: Photograph of the trench where contamination was found outside TAN-607.

6. Is the site SWMU as defined in OSWER DIRECTIVE 9502.00-6? <input checked="" type="checkbox"/> Yes <input type="checkbox"/> No	
7. Recommendation <div style="margin-left: 20px;"> <input type="checkbox"/> Recommend not including as a new FFA/CO site. This site DOES NOT warrant further investigation, does not meet the criteria for acceptance, and should not be included under FFA/CO Action Plan. </div> <div style="margin-left: 20px;"> <input checked="" type="checkbox"/> Recommend including as new FFA/CO site. This site DOES meet the criteria for acceptance, may warrant further investigation, and should be included under FFA/CO Action Plan. </div> <div style="margin-left: 20px; margin-top: 10px;"> Recommended WAG and Operable Unit to which site should be assigned: WAG: 10 Operable Unit: 10-08 Recommended action for this site: <div style="display: flex; justify-content: space-between; width: 80%;"> <input type="checkbox"/> No Action <input type="checkbox"/> No Further Action <input type="checkbox"/> Remedial Action under Existing ROD <input type="checkbox"/> Track 2 <input checked="" type="checkbox"/> RI/FS </div> </div>
